Re: Evaluation Letter
Winslow School Exterior Assessment
Town of Tyngsborough
Tyngsborough, MA
Gale JN 844980

In accordance with our agreement, Gale Associates Inc. (Gale) performed an exterior visual evaluation of the in-place facade and roof components at the Winslow School. On July 14, 2025, representatives from Gale visited the site to conduct the façade and roof evaluation.

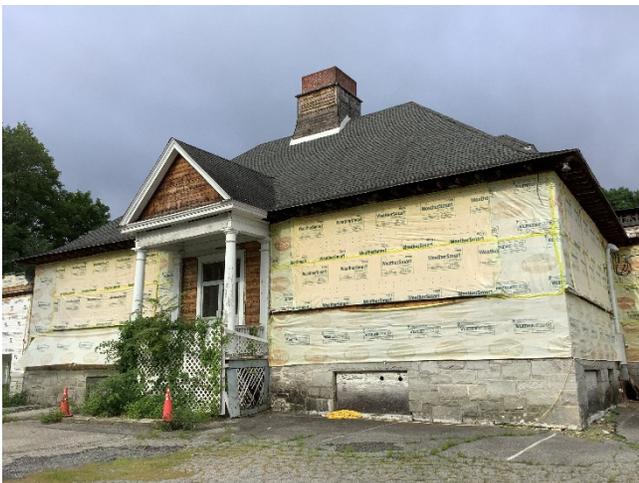
1. Due to the aforementioned abatement project, the majority of the clapboard siding had been removed. The clapboard siding that remained in place and the back-up walls, which are comprised of tongue and groove wood planks, were not fully visible due to the installation of building wrap material. Wood planks also provide back-up substrates on the cornice around the roof perimeter and the chimney enclosure.
2. Where visible and remaining, the clapboard siding exhibits peeling paint and deterioration in the form of splitting and dry rot.

Image 2: View of the front elevation of the original building that is covered with building wrap.

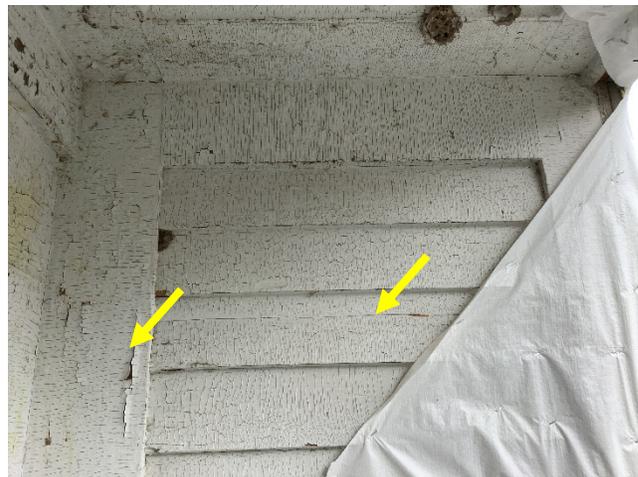
Image 3: Peeled paint and split clapboard siding components were observed.

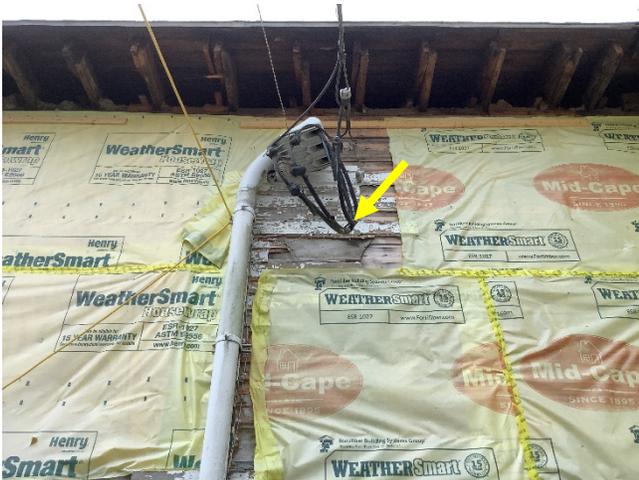
Image 4: View of peeling paint and split wood on the clapboard siding.

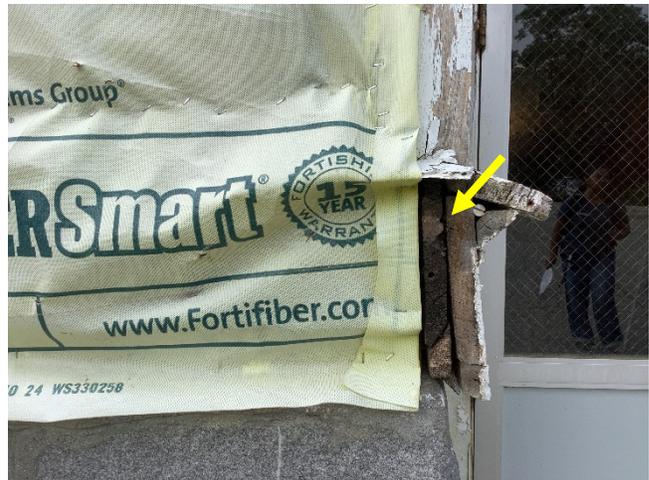
Image 5: Close-up end view of clapboard siding that is split and curled. View of split and rotted tongue and groove wood back-up walls.

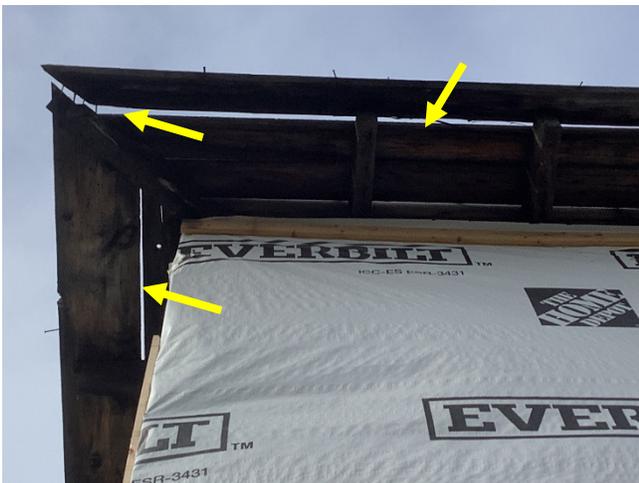
- 3. Wood planks generally exhibit water staining and splitting at several locations.
- 4. Wood planks on the cornice are detached at the corners. Wide gaps were observed between the cornice planks. Wood framing beneath the roof is exposed to the elements, also leaving the blown foam insulation exposed to moisture.

Image 6: View of detached wood substrates and gaps in the cornice substrate.

Wood cornice components are deteriorated due to their exposure to the elements. Gaps and detached components were observed along the cornice. The cornice components will need to be removed and replaced, and ultimately flashed with new membrane and sheet metal flashing, so the cornice is protected from the elements.

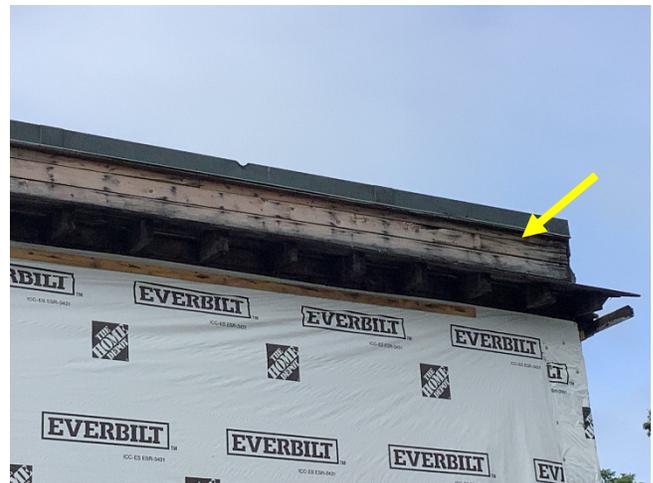
Image 7: View of deteriorated wood plank substrate above the cornice.

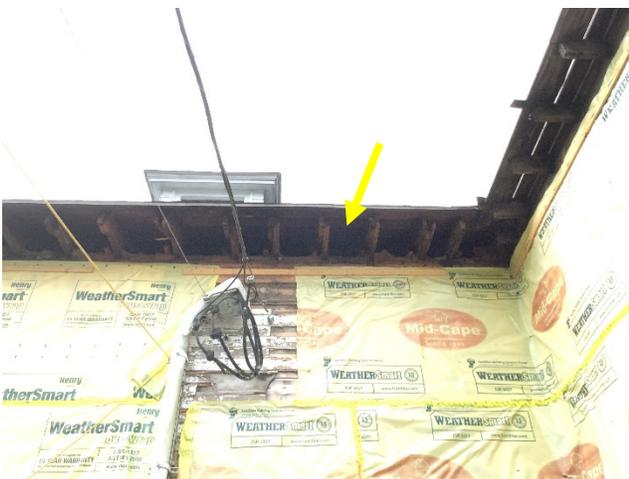
Image 8: View of exposed roof rafters and insulation that is exposed to the elements.

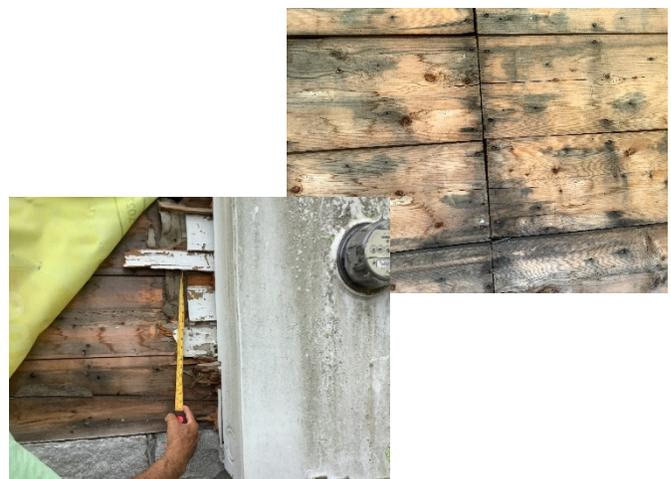
Image 9: Views of water stained and split tongue and groove wood-plank back-up walls.

Back-up substrates on the main walls and above the cornice exhibit water staining, as well as deterioration in the forms of split lumber and dry rot. Exposure to the elements over a long period of time, combined with insect infestation, has resulted in severely damaged wood framing and back-up substrates on the back side of the building. These elements need to be removed down to the granite foundation and reconstructed.

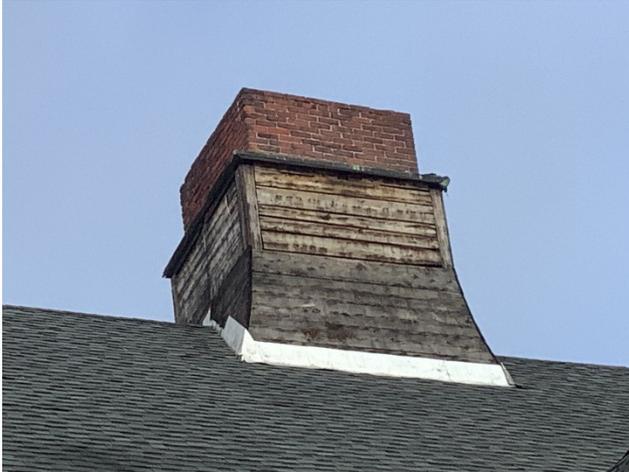
Image 10: View of deteriorated tongue and groove wood plank back-up walls that encompass the chimney.

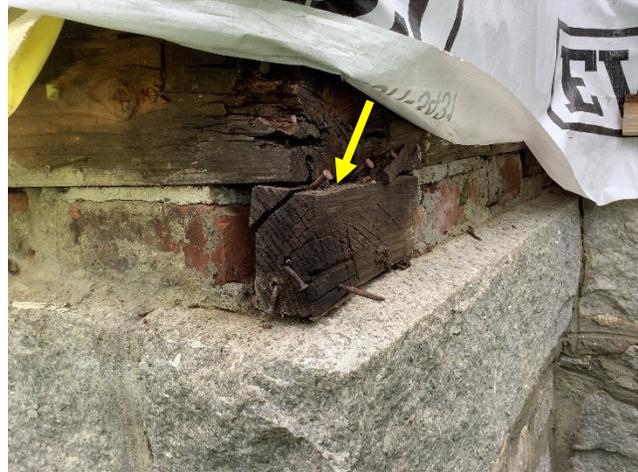
- 6. Nails that remain on the back-up walls are typically rusted.
- 7. The wood sill plate on the west side of the building is severely deteriorated. The beam also appears to be affected by insect infestation, as numerous ants were observed on the wall at this location.

Image 11: Deteriorated wood sill plate components were observed on the back of the building.

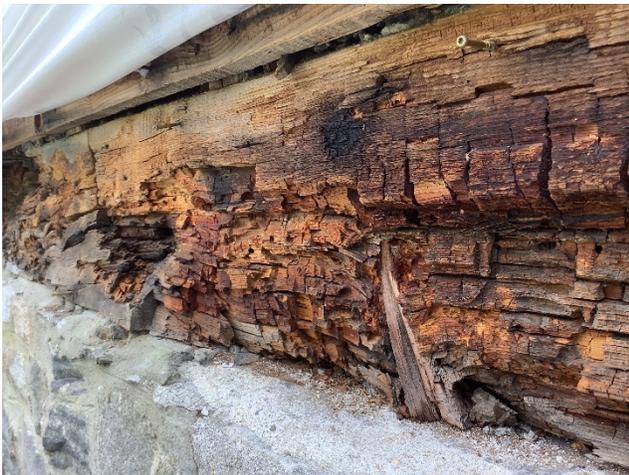
Image 12: View of a severely deteriorated wood beam on top of the granite foundation on the back of the building.

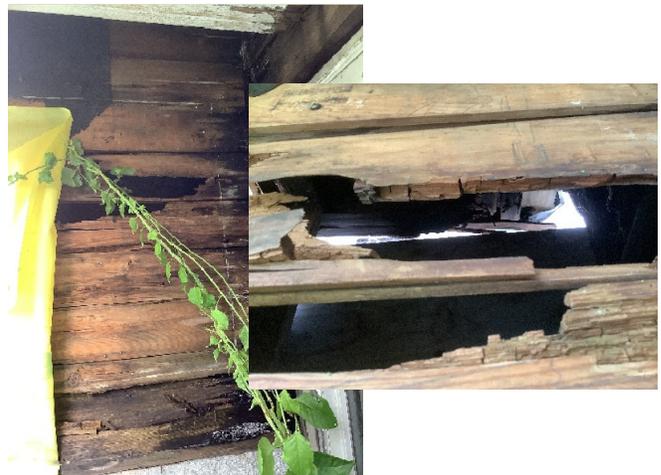
- 5. Wood planks on the west (back) side of the building are deteriorated, with several sections of missing material that appear to be due to several years of exposure to the elements combined with insect infestation. This condition is predominantly located on the back side of the building.

Image 13: Views show the deteriorated and missing sections of wood plank back-up walls on the back of the building.

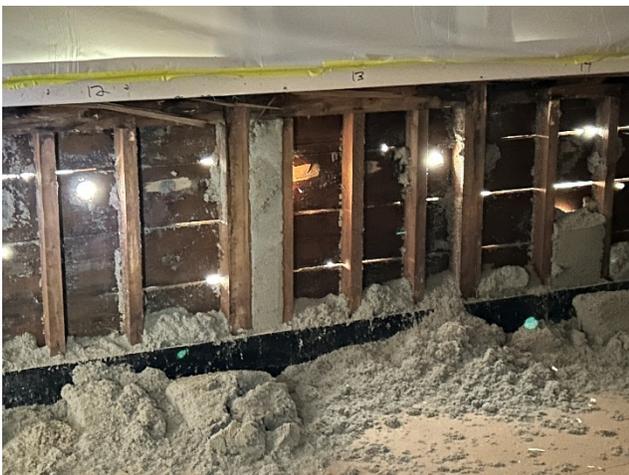
- 8. As viewed from the interior, daylight is visible through missing substrate sections, as well as gaps, splits, and holes in the wall substrate.

Image 14: Daylight was visible from the interior via gaps, cracks, and holes in the wall substrate.

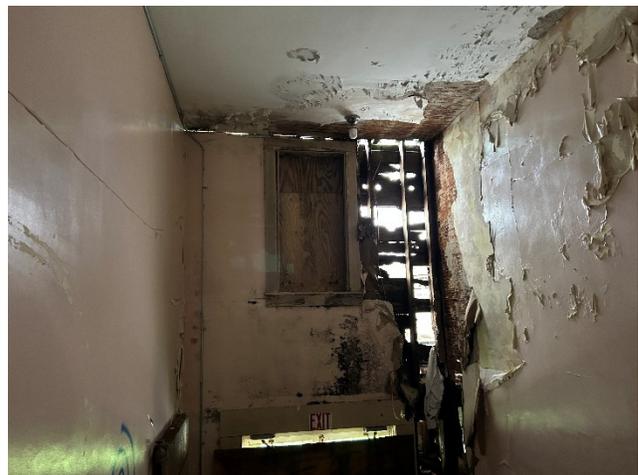
Image 15: Daylight was visible from the interior via missing and deteriorated wall substrate.

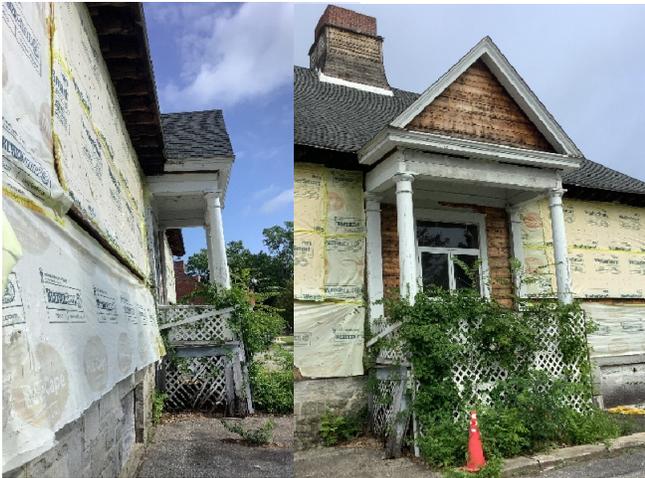
Image 16: Side and front views of the collapsed front entrance portico.

9. The front entry portico is severely damaged. Wood supports have collapsed, resulting in the collapse of the structure. The deck has also collapsed with the framing. The wood trim is deteriorated. The decorative columns are deteriorated as well, with section of material loss at the bases.

The front entrance portico is badly damaged and has collapsed. It cannot be repaired. The entire structure needs to be removed and reconstructed.

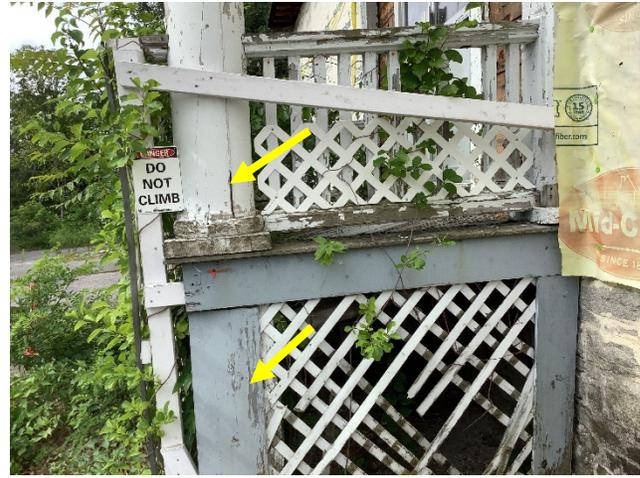
Image 17: Side view of deteriorated wood trim and column enclosure components.

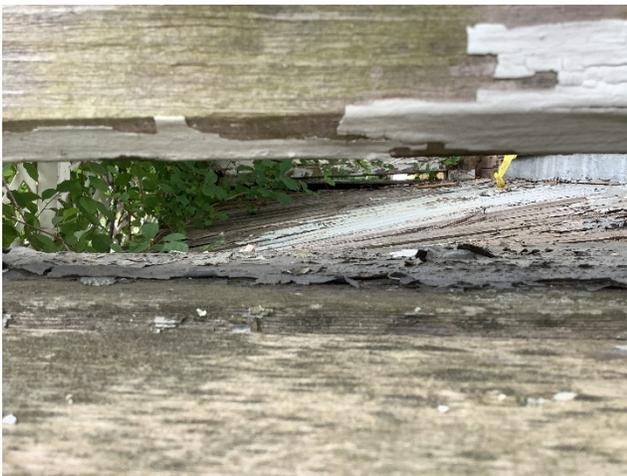
Image 18: This view shows the collapsed deck.

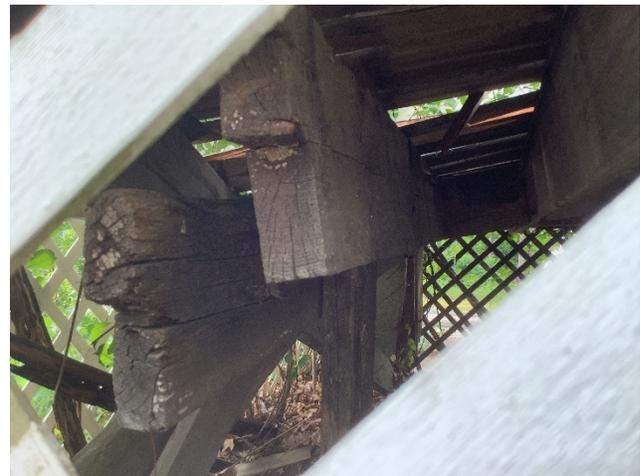
Image 19: Closer view of the collapsed framing below the deck.

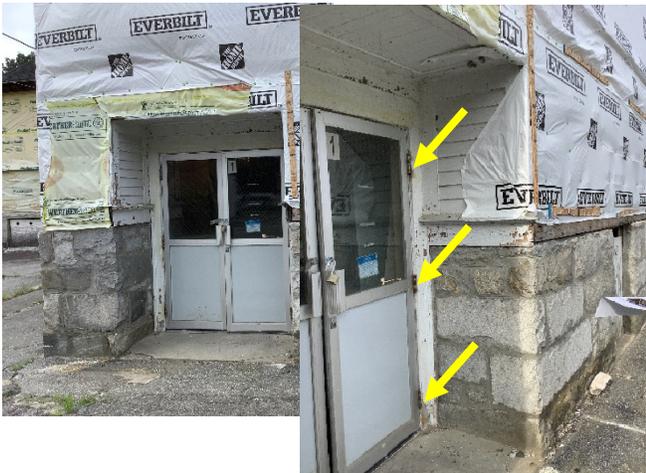
Image 20: Views of an aluminum framed entrance with rusted steel door hinges.

Aluminum framed entrances appear to be in fair condition. However, they should be replaced to match new construction and to meet current energy code requirements.

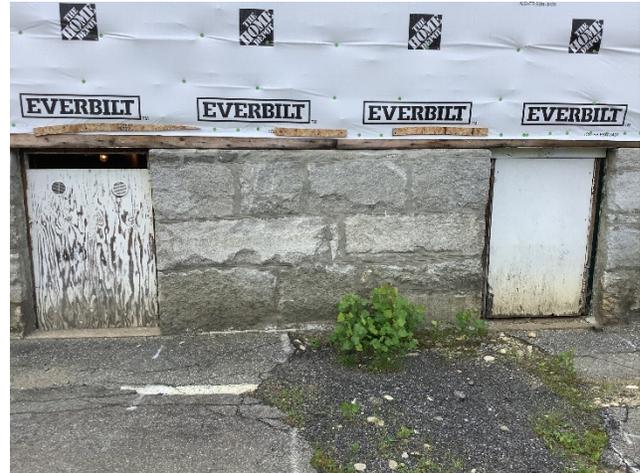
Image 21: Typical view of the granite foundation and plywood covered window openings.

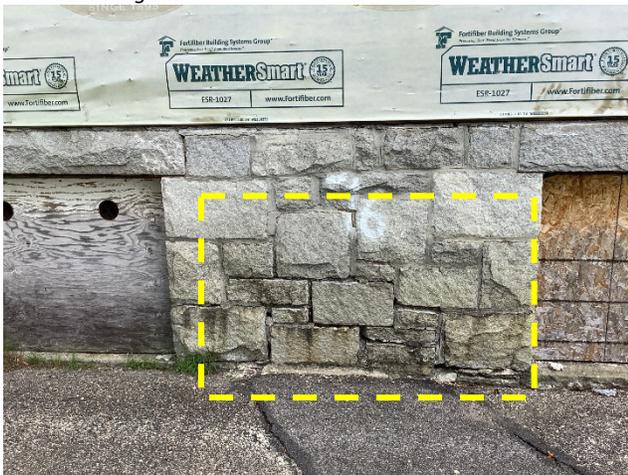
12. Mortar joints are deteriorated at several locations. Mortar joints appear to have been repaired at some locations. However, the repairs appear to consist of butter joints, which is typically a skim coat application of mortar over the existing mortar. Wet, deteriorated joints were observed on the north side of the south entrance of the building.

Image 22: View of deteriorated mortar joints in the granite foundation.

Foundation mortar joints are deteriorated and are a source of water entry inside the building. However, they can be repaired to extend the service life of the foundation walls. Repairs would include removing the existing deteriorated mortar down to sound material and filling the joints with new mortar.

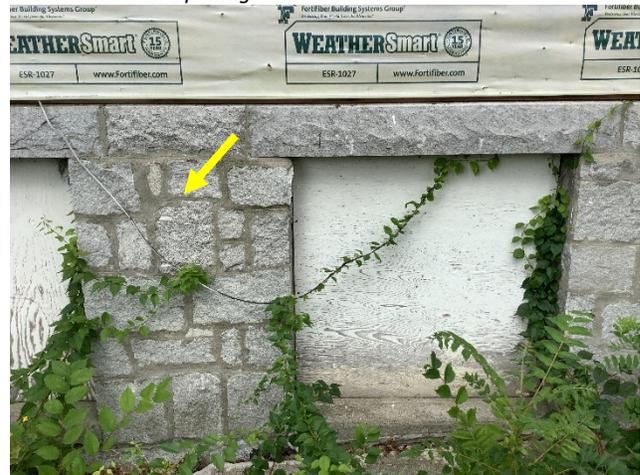
Image 23: View of previous mortar repair that appears to consist of a mortar skim coat or butter joint.

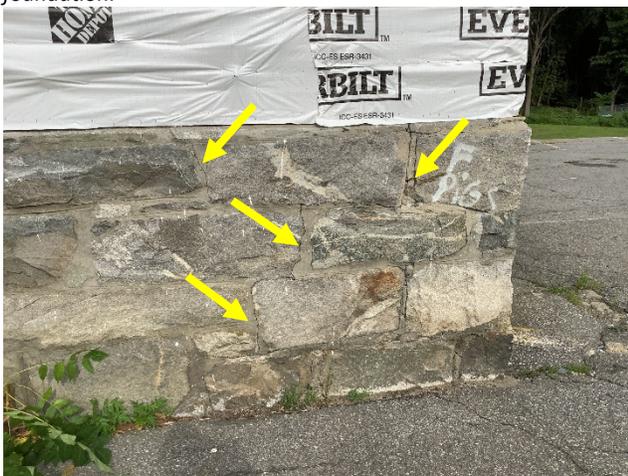
13. The foundation exhibits step cracking at isolated locations.
14. Granite windowsill components appear to have settled at some locations, as they are misaligned with the foundation.

Image 24: View of step crack in the foundation that could be associated with settling of the foundation.

Step cracking in the foundation wall could be associated with settling of the foundation at building corners. Additional monitoring is required to determine if settling is ongoing. The foundation could be repaired to address the step cracking; however, should the building be experiencing ongoing settlement, the foundation will require reconstruction of the corners and locations where components have settled. This would require excavation and underpinning the foundation.

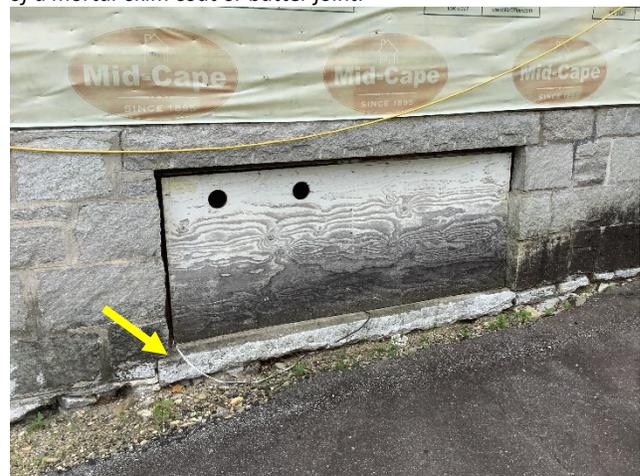
Image 25: The foundation appears to have settled as the granite and windowsill do not align.

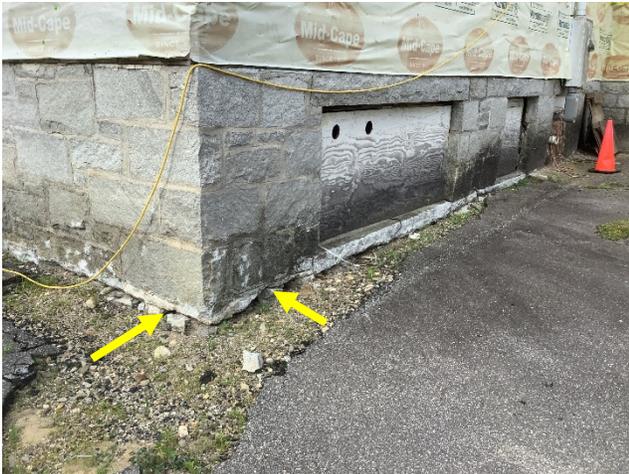
Image 26: View shows loose, displaced smaller stones at the base of the foundation, causing the corner of the foundation to settle.

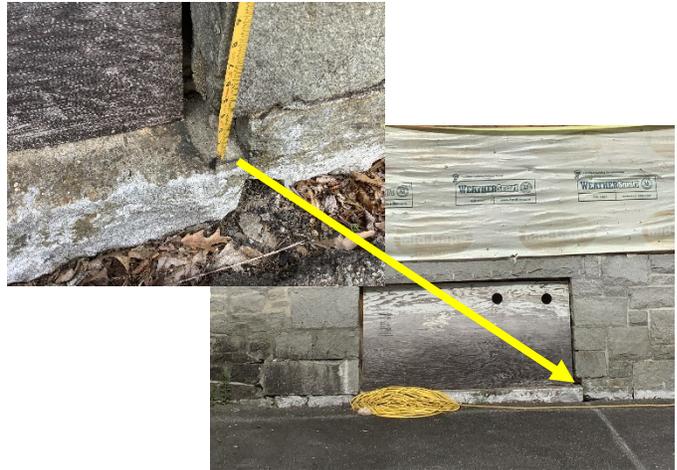
Image 27: The granite windowsill has settled and is out of alignment with the foundation.

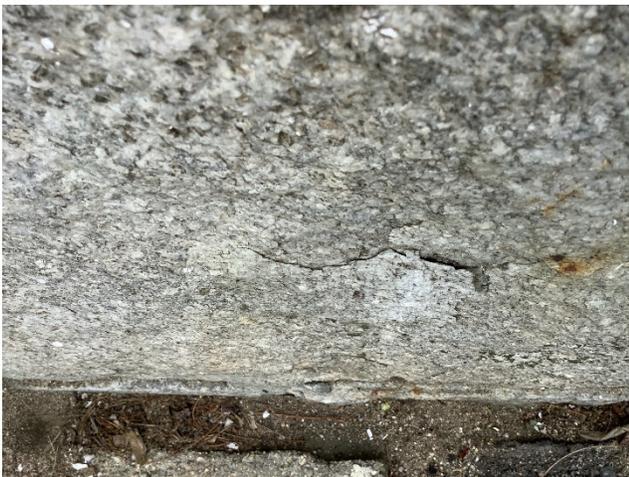
Image 28: View of delaminated granite.

Granite foundation walls appear to be in good condition with isolated delamination and cracks observed. These items can be repaired to extend the service life of the foundation components. Some granite elements have displaced, causing portions of the foundation wall – mainly the windowsills – to settle and become misaligned with the rest of the foundation wall.

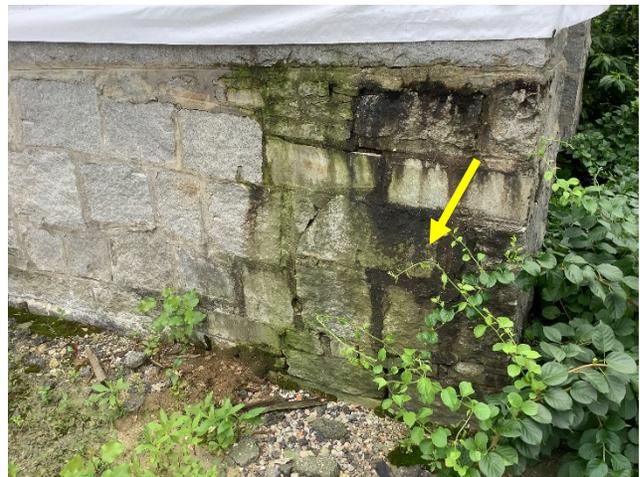
Image 29: Deteriorated and wet mortar joints were observed on the back of the building, adjacent to the entrance.

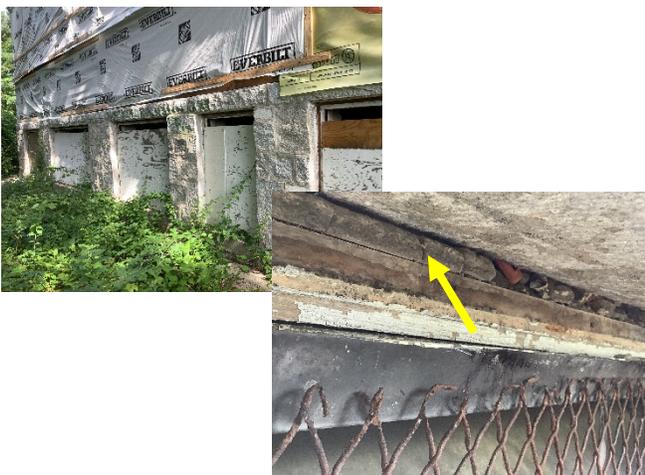
Image 30: Plywood window covers were partially open and loose. Deteriorated wood frames were observed at the window rough openings in the foundation wall.

- 15. Wood enclosures around the basement windows are loose and partially open, exposing the existing wood framing at the rough openings. The wood framing is typically deteriorated.
- 16. Steel lintels at the window headers typically exhibit surface rusting.

There are no visible windows on the building, however, the remaining wood framing is deteriorated and will need to be replaced for the installation of new windows.

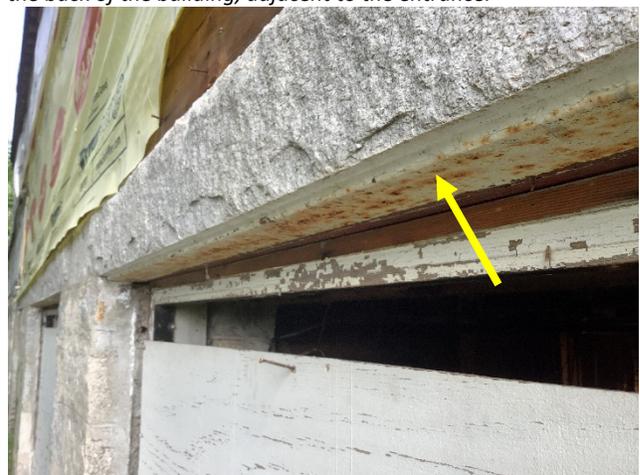
Image 31: View of a typical rusted steel lintel.

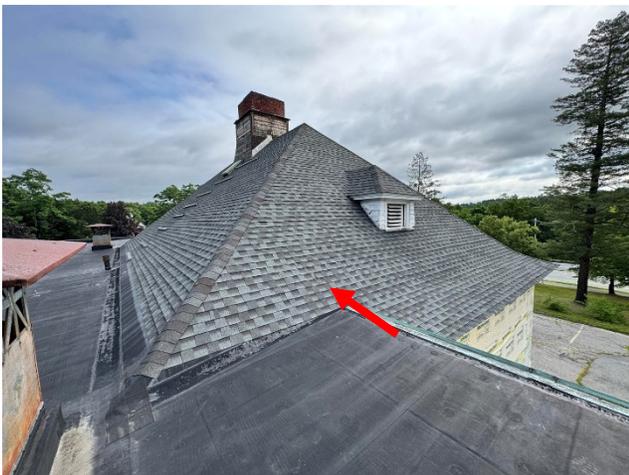
Image 32: Overall view of the asphalt shingle roof.

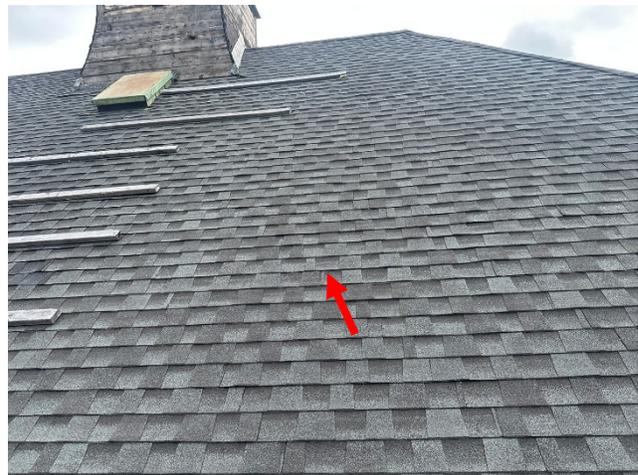
Image 33: View of typical asphalt shingles.

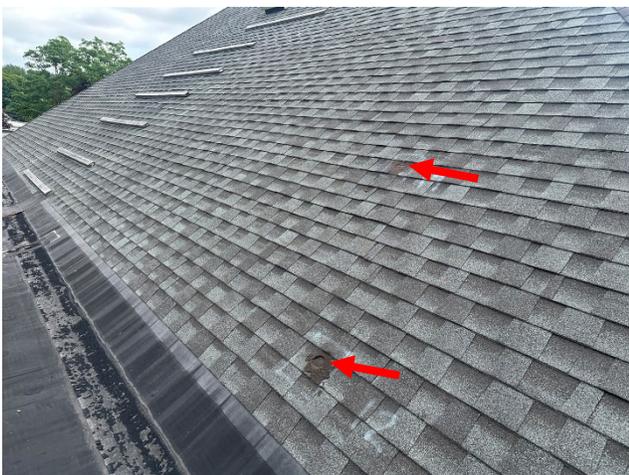
Image 34: View of previous test cut locations with deteriorated patching material.

The asphalt shingle roof system appears to be in good condition relative to the other roof systems. Only isolated defects and algae growth were observed. New shingles and underlayments should be installed at previous test cut holes to prevent moisture infiltration and extend the service life of the roof system.

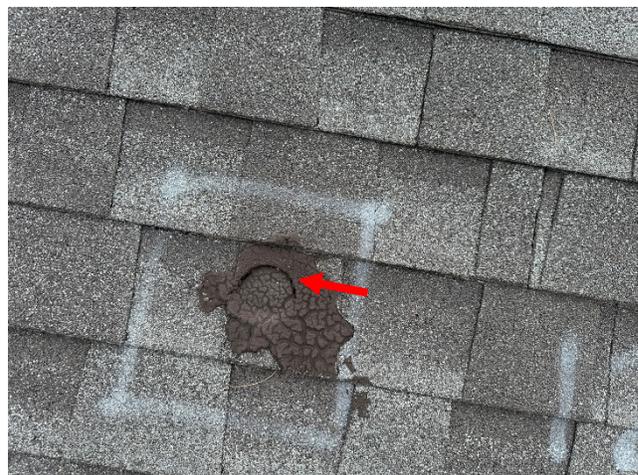
Image 35: Close-up view of an open previous test cut.

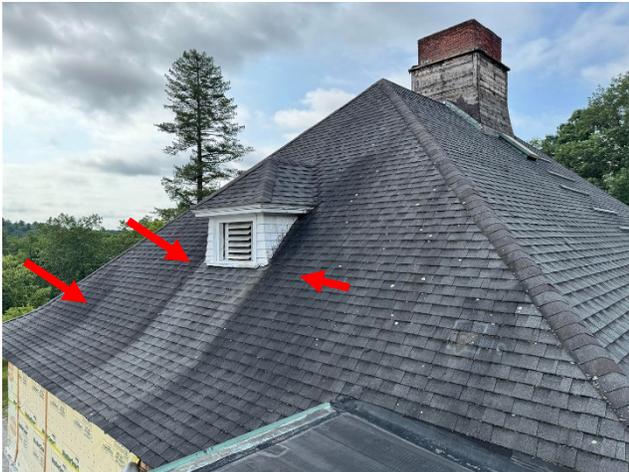
Image 36: View of north side of the asphalt shingle roof. Note black staining at portions of the roof.

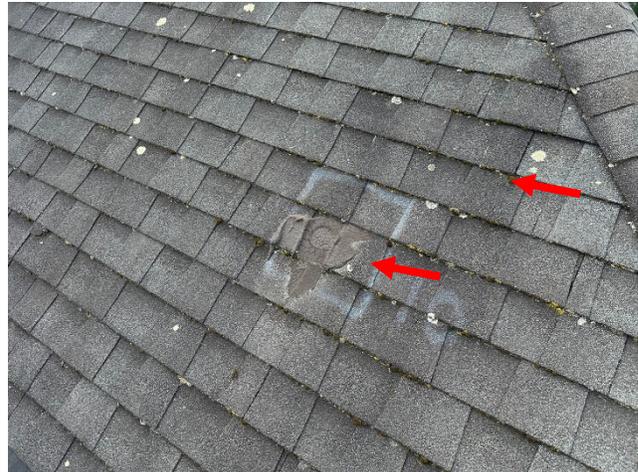
Image 37: View of moss growth under shingles and a previous test cut location.

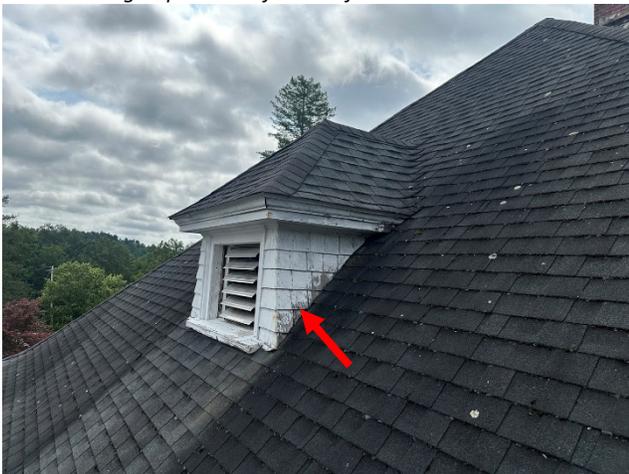
Image 38: View of the dormer on the north side roof.

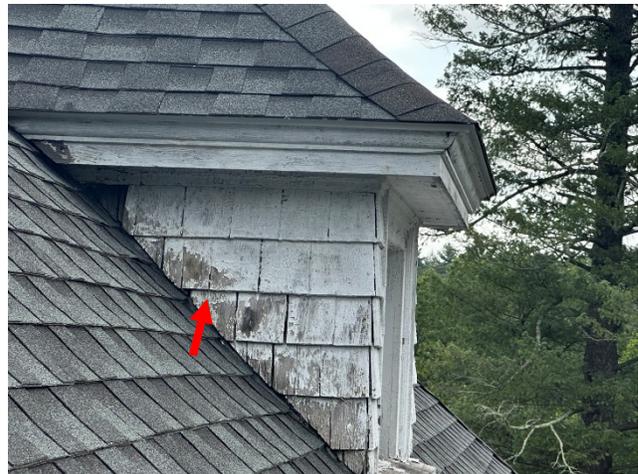
Image 39: View of peeling paint and deteriorated wood siding at the dormer on the south side roof.

3. Both the north and south elevations have one (1) louvered dormer at the center of the roof. The asphalt shingle roofs above the dormers appear to be in good condition, similar to the main roof areas. However, the painted wood siding and fascia appear to typically be deteriorated.

The siding, fascia, and other wood components at the two (2) dormers on the asphalt shingle roof are deteriorated and should be replaced. More severely deteriorated wood components were observed at the base of the dormer. If full replacement of the siding cannot be performed in the short term, repair efforts could be prioritized at these components.

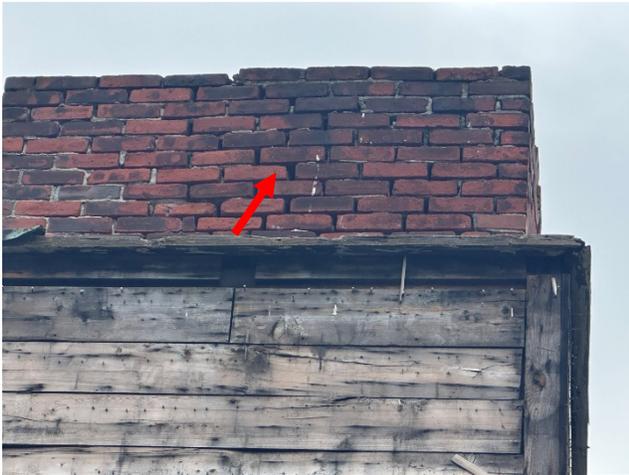
4. At the ridge, there is a brick masonry chimney with wood siding installed around the lower portions of the chimney. The masonry appears to be in poor condition, as the majority of the mortar joints appear to be open. The brick units themselves are typically stained and weathered. Additionally, the wood siding appears to be deteriorated, with gaps or missing pieces throughout.

Image 40: View of open mortar joints.

The chimney at the asphalt roof ridge is deteriorated. Completely open mortar joints were observed at a majority of the chimney. Due to the level of deterioration, the chimney will likely need to be demolished and rebuilt, or demolished and infilled during replacement of the asphalt shingle roof, if the chimney is found to be inactive and not contributing to the historic nature of the building. The wood back-up substrate around the base of the chimney is exposed to the elements. As such, it is also deteriorated and will need to be replaced, and new siding installed. Gaps at the bottom of the chimney need to be addressed to prevent moisture infiltration into the interior. Sheet metal flashing could be installed during siding installation operations.

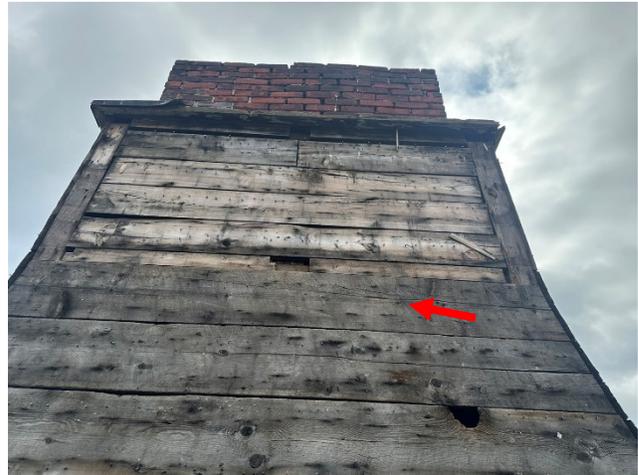
Image 41: View of deteriorated wood siding at the chimney.

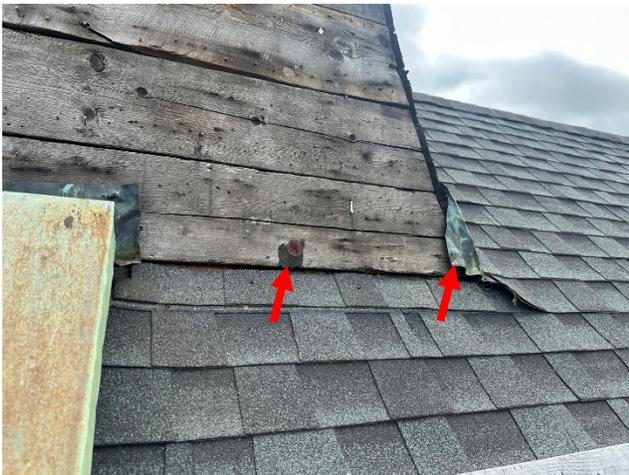
5. There is copper flashing at the base of the chimney, where it transitions to the asphalt shingles, and at the top of the siding. The flashing at both locations appears to be typically deformed and completely missing at isolated sections. At a section of missing flashing at the base of the chimney, a gap was observed between the siding and the asphalt shingles, exposing the interior attic space.

Image 42: View of deteriorated copper flashing and a gap at the base of the chimney.

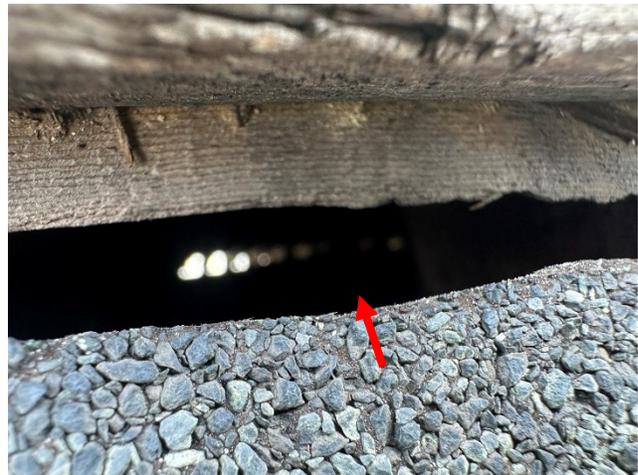
Image 43: Close-up view of the gap at the base of the chimney.

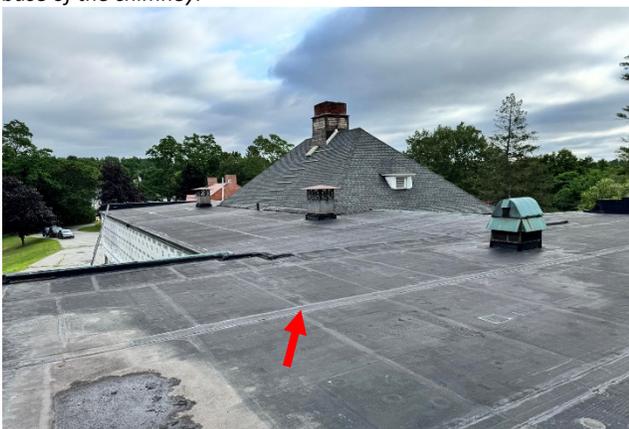
6. The low-slope EPDM roof systems appear to be in poor condition. Tears/openings and other membrane defects were observed throughout the roof. As seen at the asphalt shingle roof, there are several previous test cuts with failed patching material. At the roof edge, stripping/flashing membranes at the base of the parapet and over the roof edge metal are typically cracking or splitting. At some isolated locations, the cracking is severe, and sections of the membrane are missing.

Image 44: Overall view of the EPDM roof system.

The EPDM membrane roof systems at the two (2) additions are in poor condition. Gale observed openings in the membrane, unadhered membrane seams, and cracking membrane throughout the roofs. Moisture infiltration through these openings has likely deteriorated the roof system below the membrane and the wood roof deck. The EPDM roof systems require emergency repairs and will need to be replaced to provide a long-term watertight condition. During replacement, deteriorated materials identified will need to be repaired, including repairs to the roof deck if it is found to be deteriorated. Temporary repairs, such as patches over membrane openings and stripping membranes over unadhered membrane seams, could prevent further damage to interior components affected by moisture infiltration through the roof if full roof replacement cannot be performed in the short term.

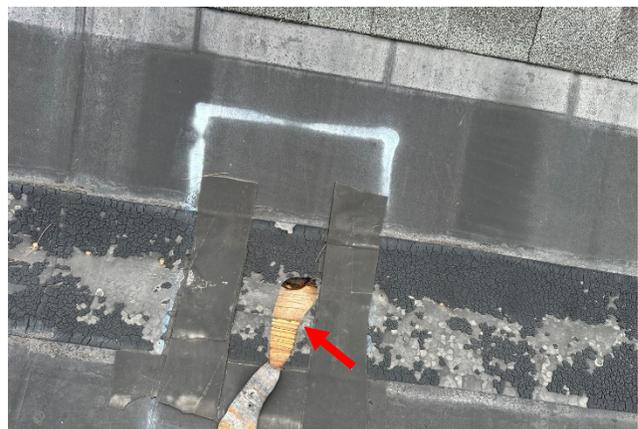
Image 45: View of an open, previous test cut location.

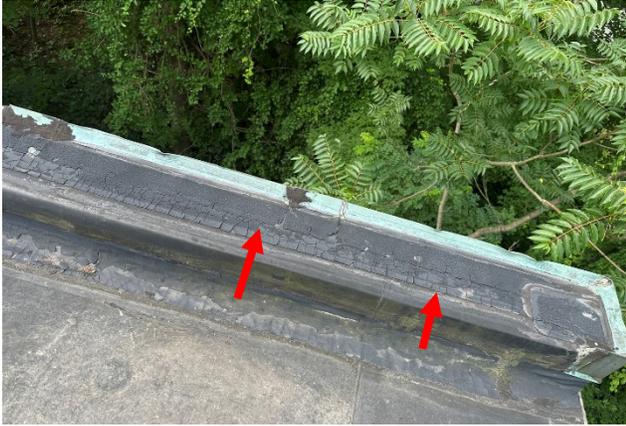
Image 46: View of cracking stripping membranes.

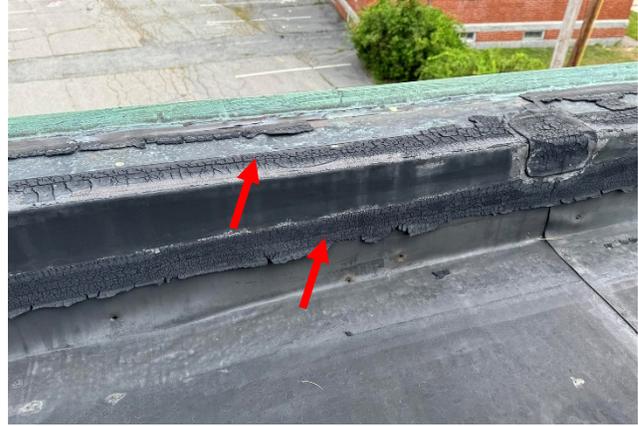
Image 47: View of severely cracking stripping membrane.

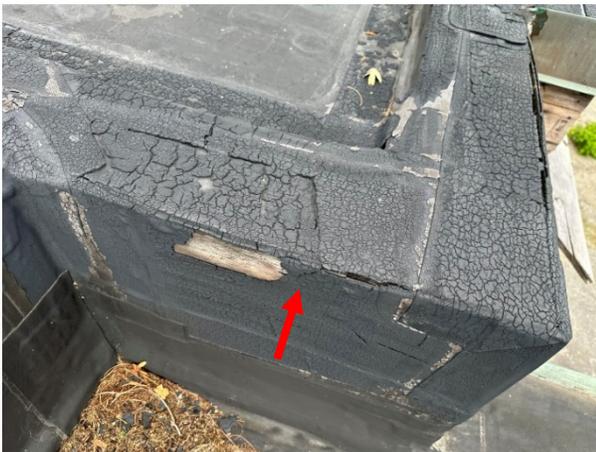
Image 48: View of severely cracking flashing membrane.

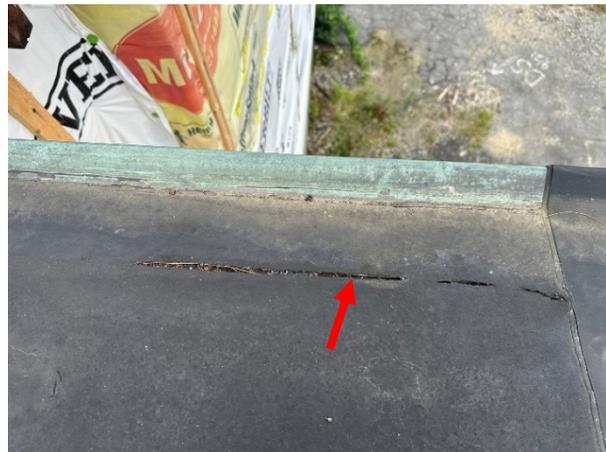
Image 49: View of open roof membrane.

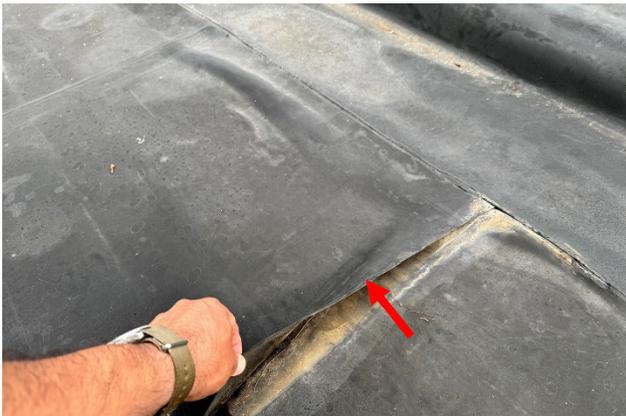
Image 50: View of cracking stripping membranes.

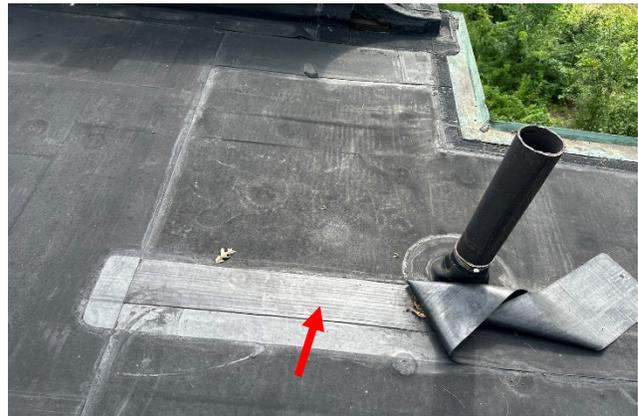
Image 51: View of unadhered stripping membrane.

7. A majority of the membrane seams appear to be partially unadhered along their whole length and could be “peeled back” approximately 1 to 2 inches. Isolated stripping membranes are completely unadhered.
8. There is a copper roof edge fascia around the perimeter of the EPDM roofs, which appears to be in poor condition. Sections of the fascia are deformed, and isolated lap joint covers are partially detached. At an isolated parapet location, the membrane is terminated with copper flashing; the copper at this location is additionally deteriorated. Drainage on the roof is provided by three (3) copper downspouts that appear to be in fair condition relative to the other copper components.

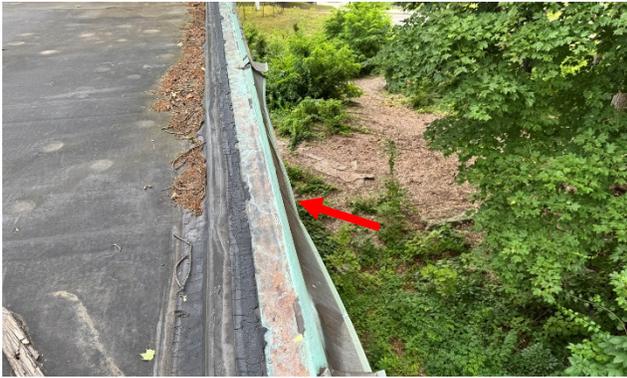
Image 52: View of deformed copper fascia.

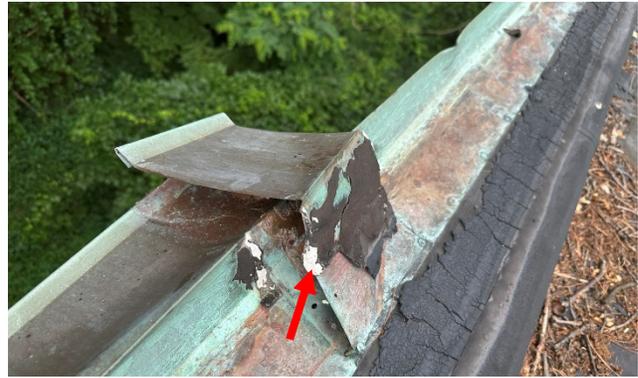
Image 53: View of a detached fascia lap joint cover.

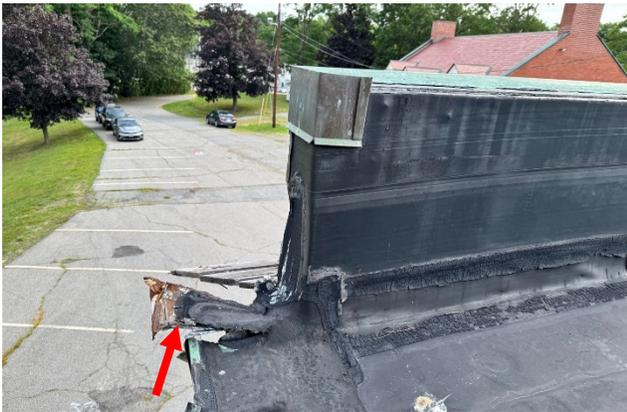
Image 54: View of deteriorated copper fascia.

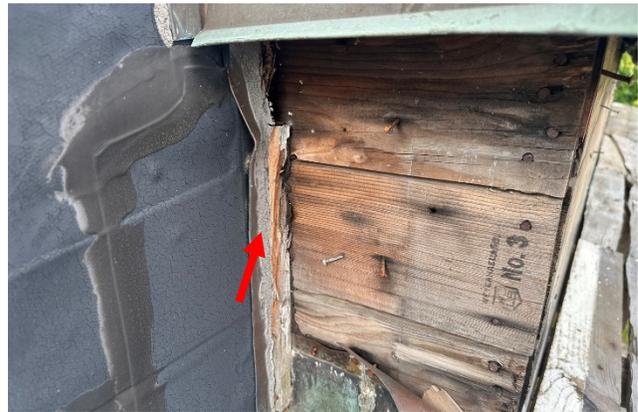
Image 55: View of deteriorated copper termination flashing.

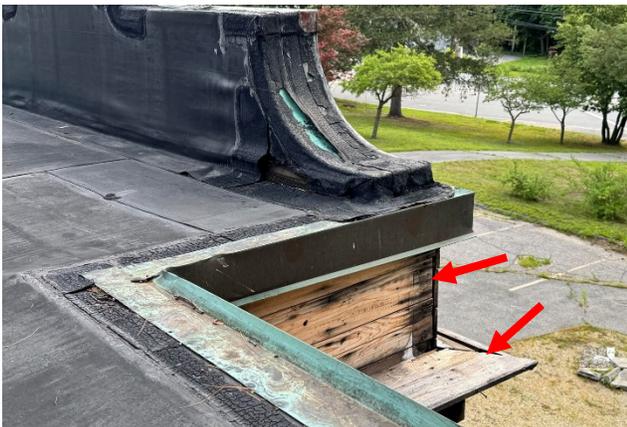
Image 56: View of deteriorated, exposed wood at the parapet and cornice.

9. At the parapet and cornice around the EPDM roof areas, there are exposed wood components. The parapet and cornice appear to have previously been clad with copper flashing, which has since been removed, leaving the wood exposed to the elements. As such, the wood components typically appear to be severely deteriorated.
10. Sealants at vent pipes and other isolated penetrations are typically failed.

Like the wood cornice, the wood parapet components at the addition roof edges are deteriorated due to their exposure to the elements. Gaps and detached components were observed along the parapet. The parapet components will need to be removed and replaced, and ultimately flashed with new membrane and sheet metal flashing, so the parapet is protected from the elements.

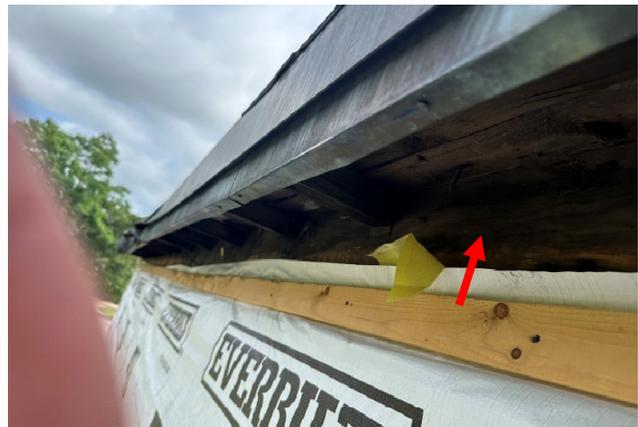
Image 57: View of deteriorated, exposed wood at the roof edge.

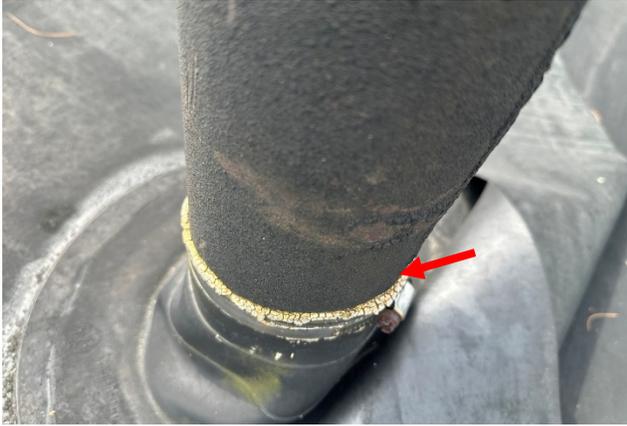
Image 58: View of failed sealant at a vent pipe.

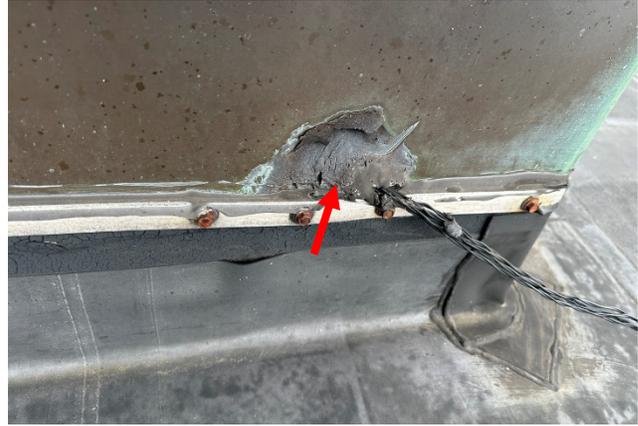
Image 59: View of failed seal around a conduit penetration into a vent.
